# THE PERFECT MATCH

BATHROOM PRODUCTS HAVE COME A LONG WAY OVER THE PAST NUMBER OF YEARS AND THE HUMBLE TOILET PAN HAS SEEN SOME OF THE LARGEST DEVELOPMENTS OF ALL. **TERRY NGUYEN** EXPLAINS THAT WHEN IT COMES TO TOILETS PANS AND FLUSHING SIZES, ONE SIZE DOES NOT FIT ALL AND FINDING THE PERFECT MATCH IS A MUST.

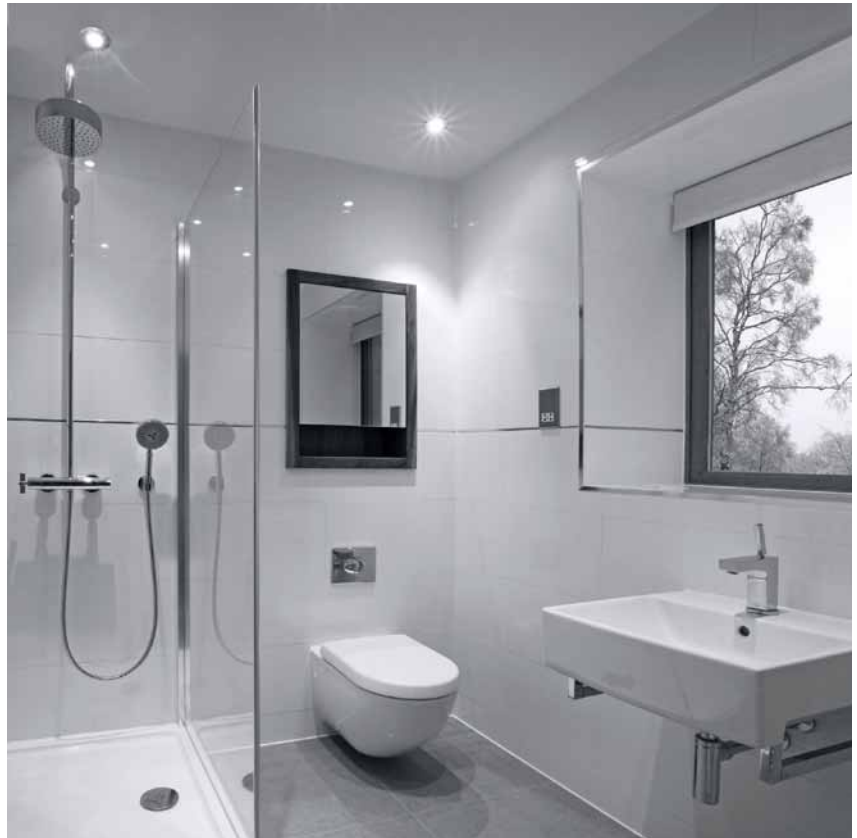
Toilet pans matched with an incorrect flushing device can cause many issues.

The flow rate and pressure changes the way water is dispersed around the rim to correctly cascade down into the bowl in the right locations. If not correct, the pan's performance can be severely affected. Insufficient flow usually means that the front of the rim is starved of water, and aggressive flow often results in water splashing onto the bathroom floor. New style rimless toilet pans can be particularly sensitive to incorrect flush conditions.

range of toilet pans in various set up situations. There are instances however, where the hydraulic design of pans can alter the internal behaviour of the flushing device [including electronic valves] where incorrect or inconsistent volumes are discharged. PROVE has seen instances where flushing devices can deliver too much, or too little water when coupled with a pan outside of the device's operating capability.
